**REQUEST FOR PROPOSAL
for
BUILDING DEMOLITION
TOWN OF LAMONT**

ADDENDUM #1

**PRE-DEMOLITION HAZARDOUS MATERIALS ASSESSMENT
OLD PUBLIC WORKS BUILDING
LAMONT, AB.**

August 2018

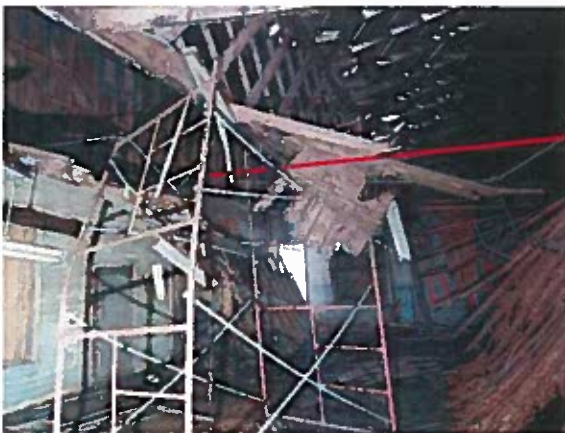
RH Services Inc. undertook an inspection of the building on August 24th, 2018. The plywood was removed from the North west door to gain access. The interior ceiling had collapsed, one area had been shored up using a safeway style scaffold, this had since buckled and collapsed. The south end was completely inaccessible. The basement was flooded to ground level and not accessible, the wood floor over the basement was rotten and posed a risk to anyone walking on it. No suspected asbestos containing materials were observed above grade.

Buckled safeway style scaffolding supporting the weight of the collapsed ceiling.

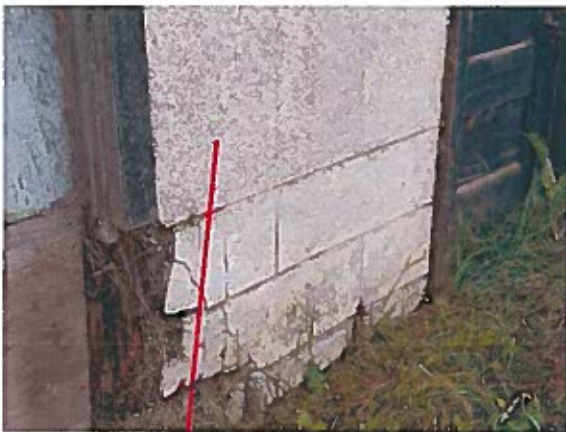
Stucco and window caulking were sampled from the exterior walls and were both found to contain asbestos (Chrysotile 1-5% and Chrysotile 10-20% respectively).

Stucco (common).
Chrysotile 1-5%

Due to the deteriorating condition of the structure, removal of the asbestos materials would put workers at risk. We suggest applying for permission¹ to demolish the building following Wet-demolition procedures. It is ill-advised to have abatement workers remove materials from the structure as it will further weaken the structure and endanger the workers.

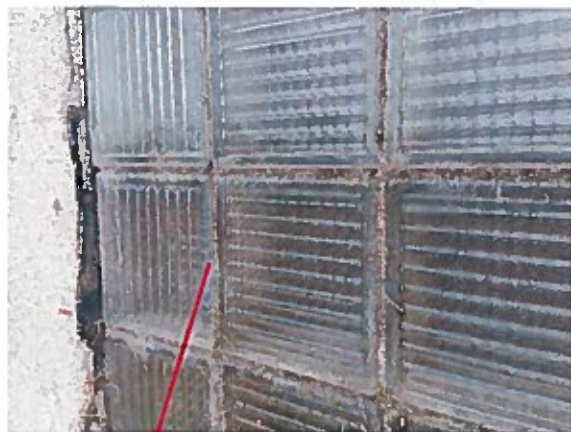
Window caulking at front of building.
Chrysotile 10-20%

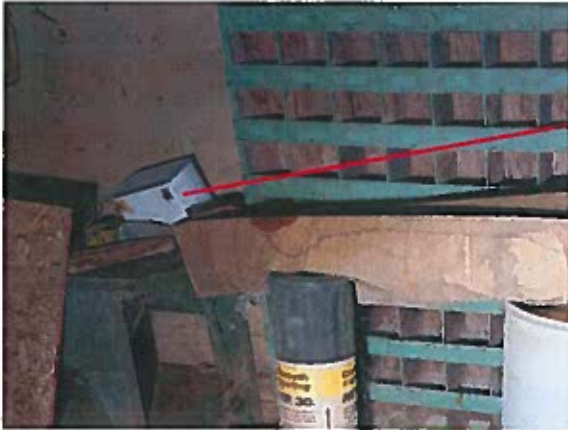
One lead-acid battery was noted within the building.

Lead-acid battery noted within the building.

The removal of Fluorescent light fixtures, used tyres, lead-acid battery and miscellaneous chemicals, paints, oils, and cleaners cannot be justified as their removal would endanger the lives of abatement contractors.

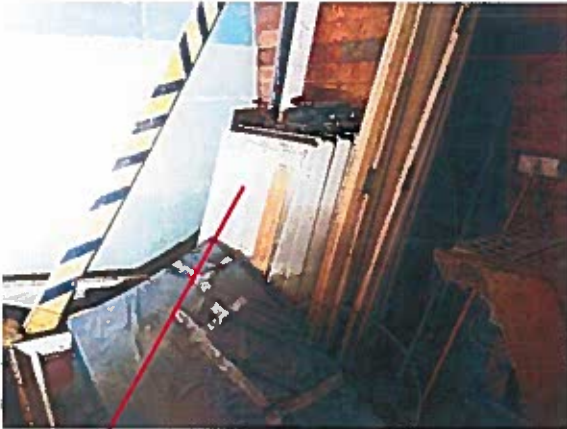
Ballasts and Fluorescent light fixtures can contain PCBs.

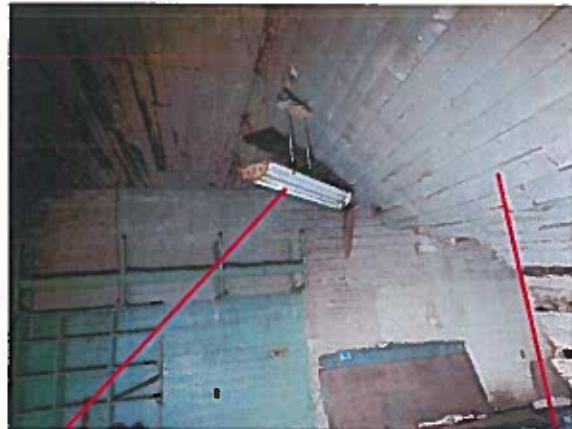
Tubes in Fluorescent light fixtures contain Mercury.
Note falling ceiling.

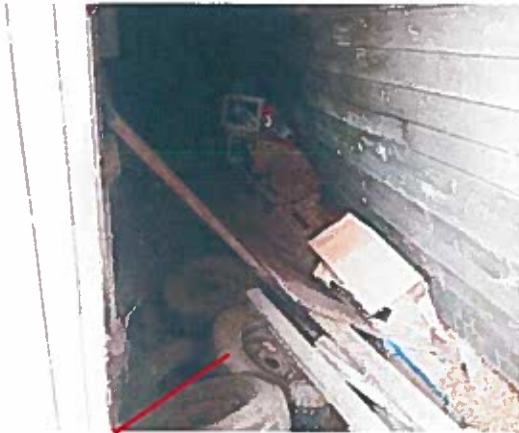
Used tyres noted in the structure.

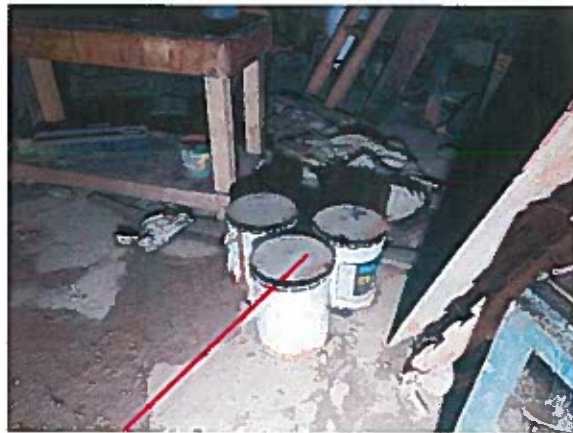
Miscellaneous paints and chemicals noted within the structure.

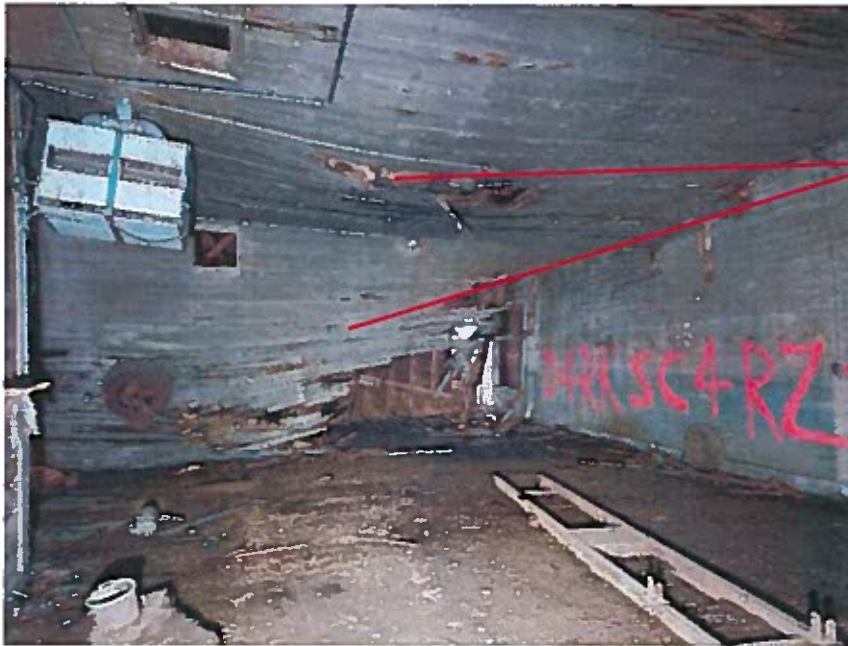
Please note that access to the structure should be limited due to excessive structural damage. Any disturbance to the structure in its current state will further weaken the framework increasing the likelihood of a collapse. The following images show the poor condition of the structure.

Image shows major damage to the ceiling of the structure.

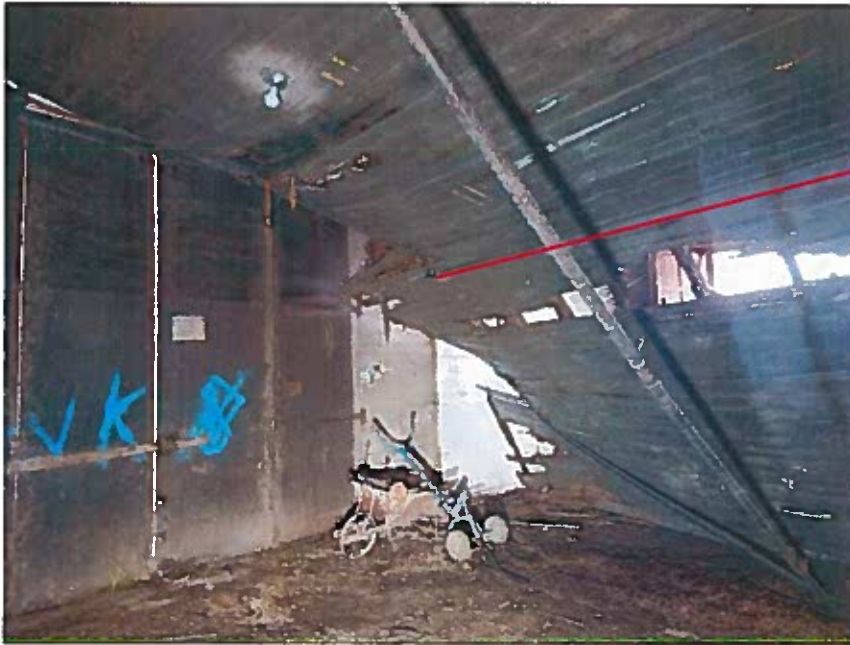
Image shows partially collapsed ceiling.

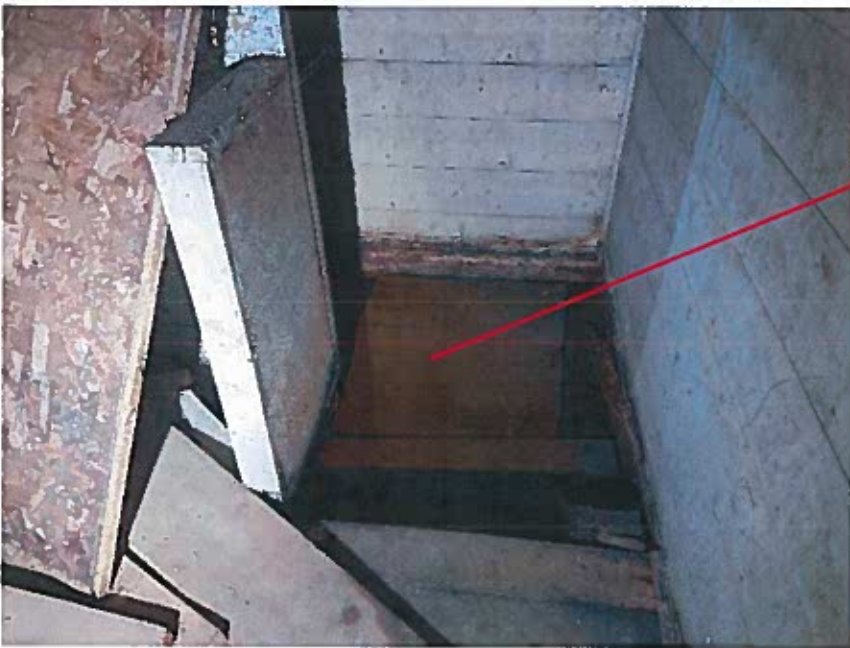
Image shows stairwell to basement completely submerged in water.

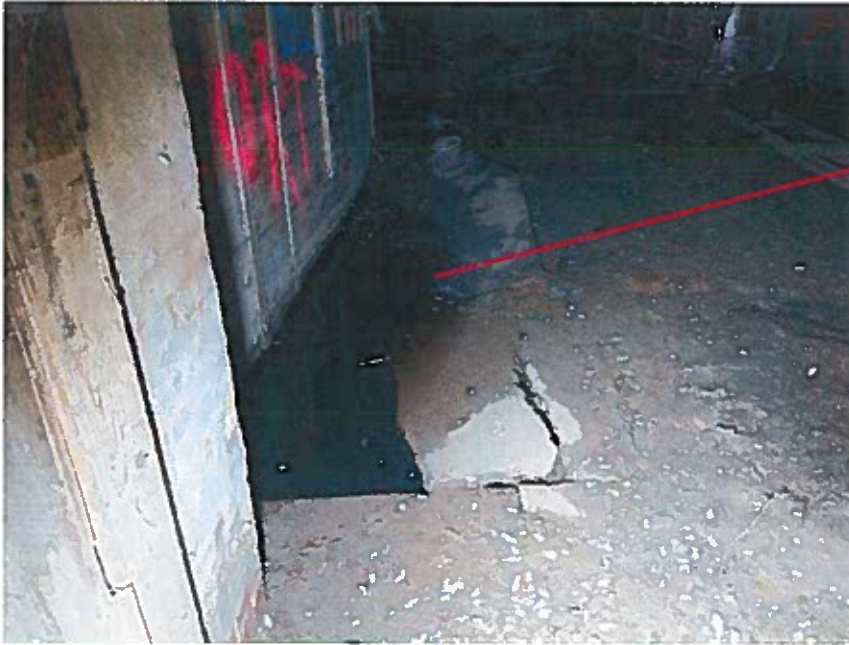
Image shows a large hole in the floor filled with water.

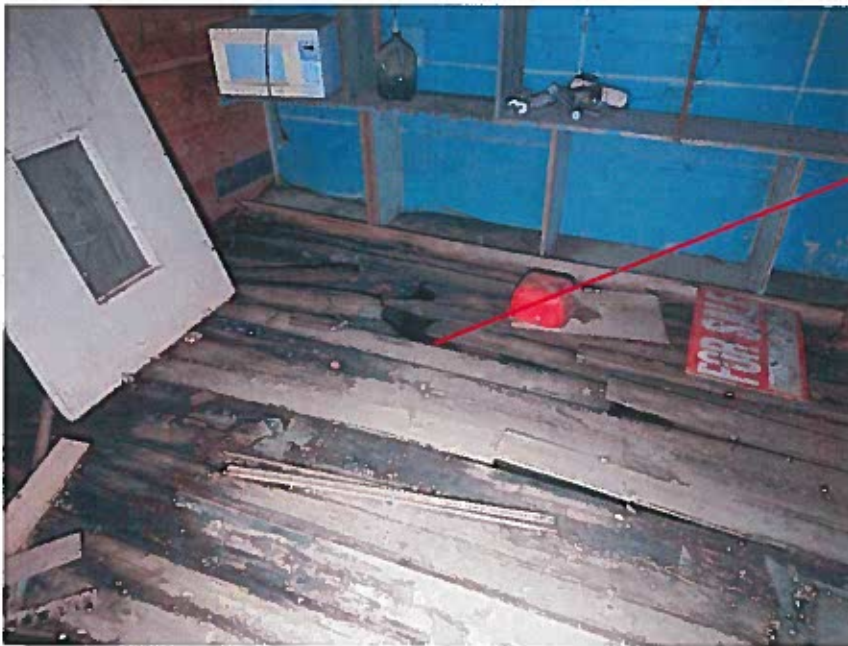
Image shows dangerous flooring with rotten floor boards.
